# A New Life For An Opera House

The Phoenix rises from the ashes a second time, and thanks to the efforts of a caring community, her past glory is restored.

By Jon McGraw  
Alloy Casting Co. Inc.

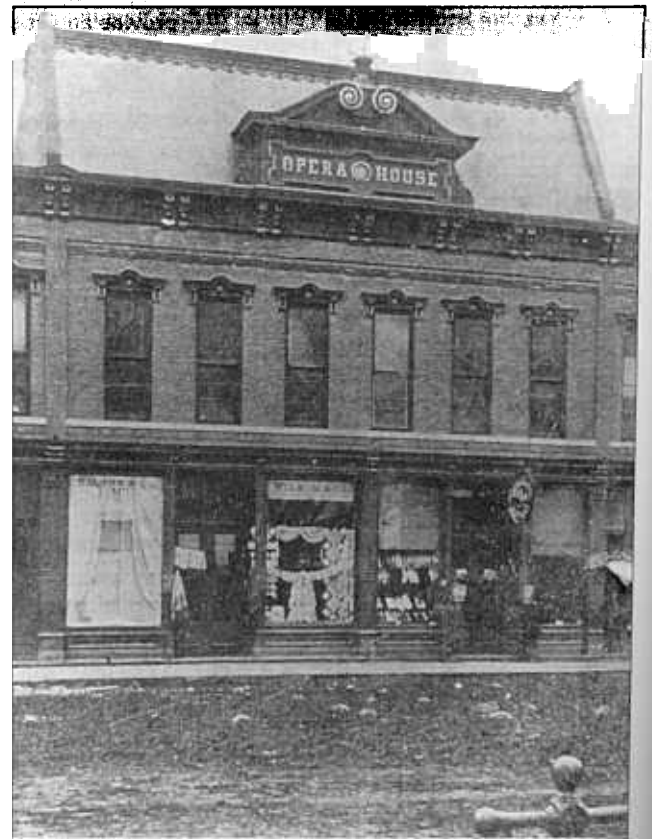
FIG. 1: The original opera house was built in 1882, and served the public for many years until its audience was lured away by movie theatres. Efforts to revitalize the building in the 1990s were well underway until a lightning strike badly damaged the building in 1995. Despite this setback, the building renovations continued, and in 1999, Alloy Castings Co. Inc. was called in to replicate the castings that once adorned the facade.

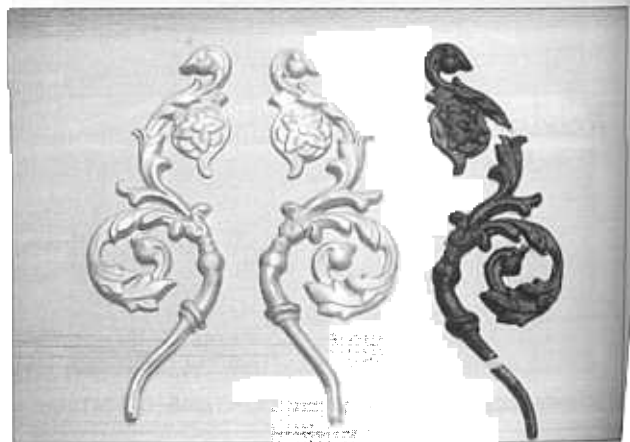
FIG. 2: After the long years and fire had taken their toll, there was little left of the facade castings. Only one broken and fire damaged piece was available for making the new patterns.

The original cast iron pieces in the building were a left hand and a right hand matched set. They were 7 inches wide by 20 inches long and flat on one side. From the many pieces that were originally on the building, only one broken, fire damaged piece was recovered (Fig. 2). From this one piece the pattern maker made a new original pattern and a matching mirror image pattern.

The duplication process consisted of repairing the one original casting with epoxy, making a mold from the original, and making a new epoxy pattern from the mold. Using the one good left side pattern as a guide, a new right side pattern was carved from wood and used as the missing match. The original left side and re-carved right sides are indistinguishable. The one epoxy duplicate and the one wooden re-carved piece were then mounted to wood pattern boards. Aluminum castings were made from the boards. The project was accepted on August 25, 1999 and the final shipment of 20 left castings and 20 right castings was made September 29, 1999. Figure 3 shows the left and right pieces on the finished facade.

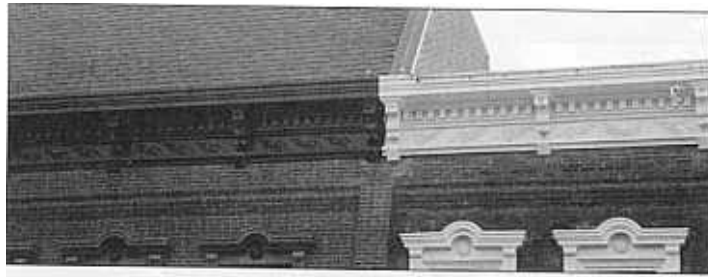
FIG. 3: The left and right pieces form a delightful pattern on the recently-completed facade.
