“Marine grade castings!”

■ A pictorial survey of eight case studies suggests that using marine grade castings and a modified powder coating application to avoid degassing results in long lasting beautiful aluminum castings, even in harsh salt water environments.

By Jon McGraw
Alloy Casting Co. Inc.

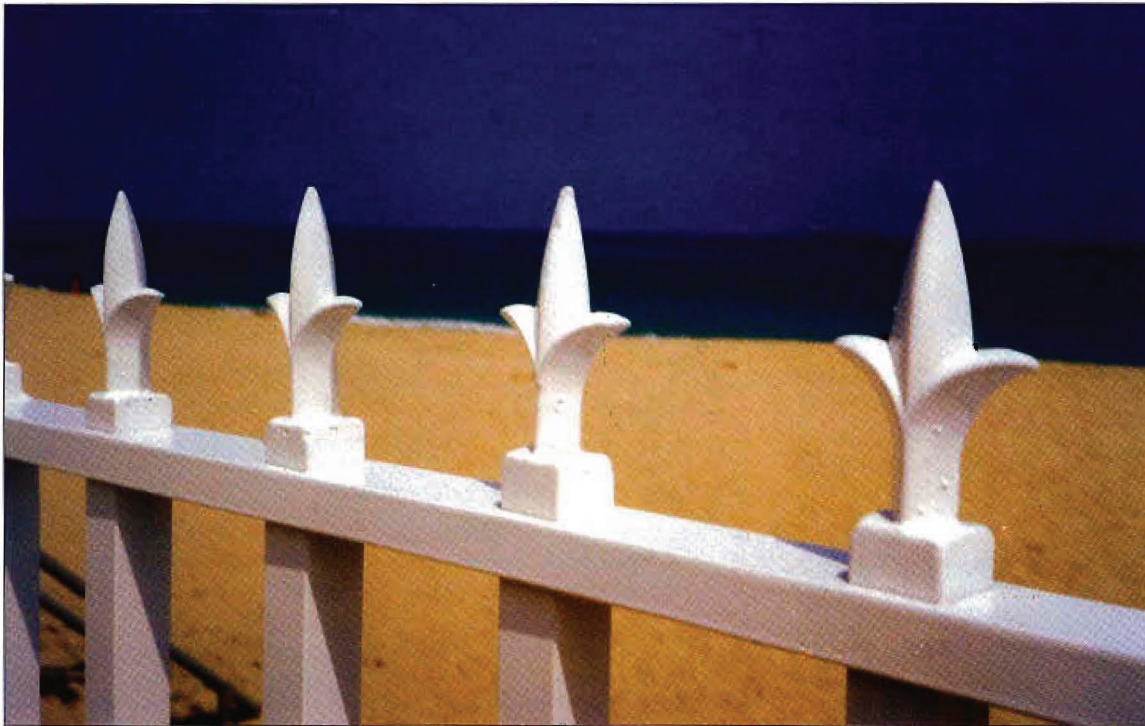
These spear points illustrate the coherent coating of marine grade castings in excellent condition after one year on the beach.

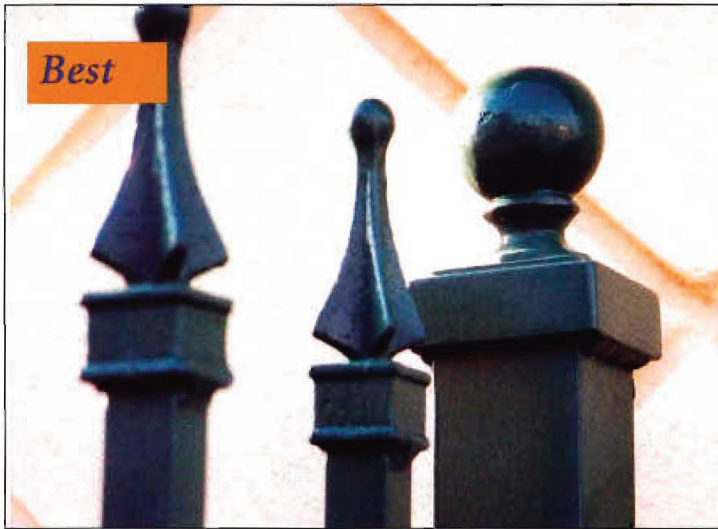
This marine grade and well powder coated spear and ball cap located just 100 yards from the ocean is in excellent, coherent condition after 3 1/2 years.

A recent on-site survey of many copper-free marine grade castings that have been on the ocean between one and 3½ years shows the excellent results of combining marine grade castings with good powder coating applications. Shown below and on page 34, the castings are coherent and show no signs of corrosion or flaking.

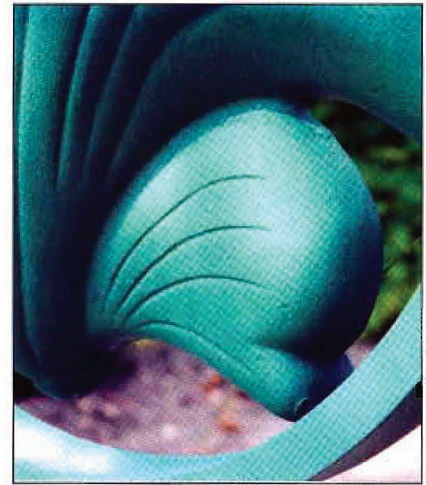
This marine grade large, heavy seashell aluminum casting adorning an exterior fence located between the Intracoastal Waterway and the Atlantic ocean shows a coherent coating in excellent condition after two years.

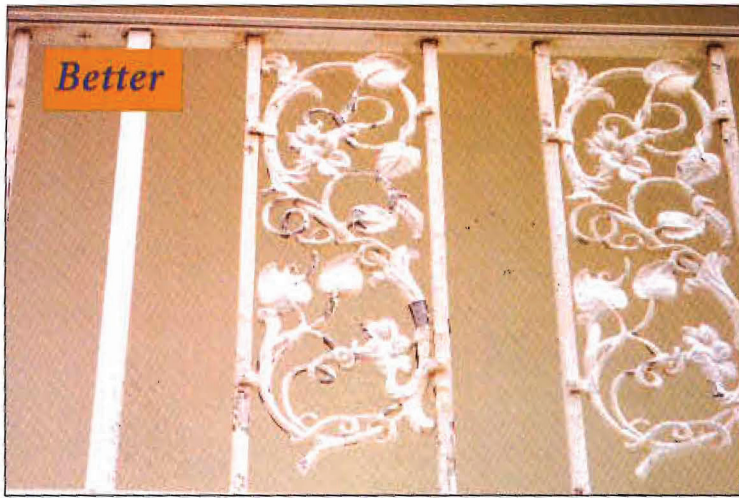
This flower panel in West Palm Beach, FL, shows flaking because of a poor coating job. But its marine grade castings are still shiny and coherent after eight years.

poor powder coating application, the net effect is still a poor looking rail. Compare this picture at left with the non-marine grade aluminum castings that have been on the ocean only 18 months (top of page 29). Marine grade castings on the ocean eight years with no corrosion pictured at left show the value of the proper base metal. Again, however, even the marine grade metal could do nothing to improve the original poor powder coating.

Even the use of virgin metal with the correct marine grade chemistry, however, cannot cure the faults of a poor coating application. Pictured at the top of page 32 is a handrail installed near the ocean in Palm Beach, FL. For eight years the castings have been directly exposed to the wind and spray of the ocean. However, they are still shiny and coherent. This shiny and coherent surface indicates no galvanic corrosion has occurred as the marine metal has successfully resisted the salt air. But because of the

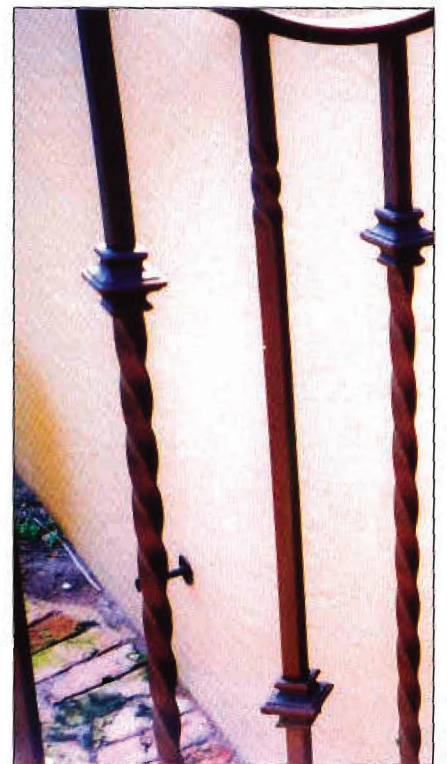
This aluminum rail with marine grade aluminum cast collars also shows a coherent coating in excellent condition after three years on Florida's Intracoastal Waterway.

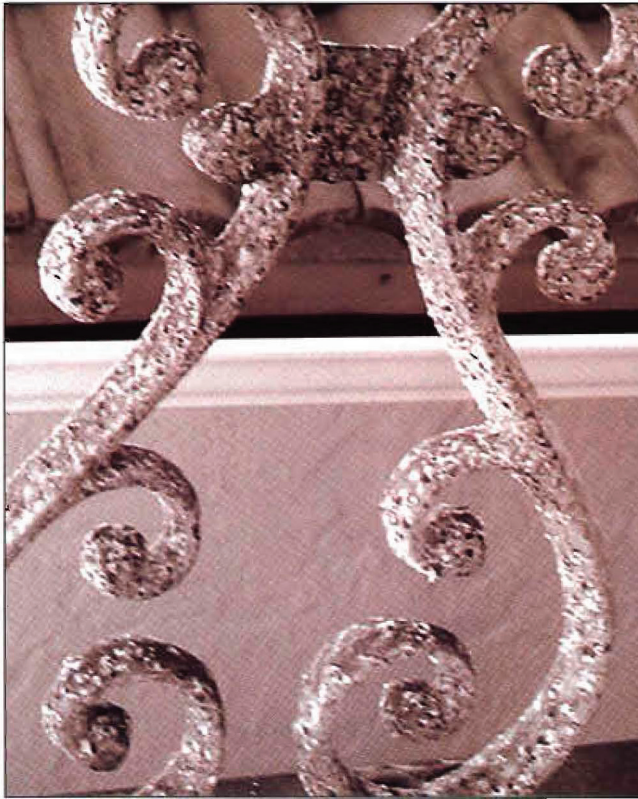
This scroll casting is not marine grade. It shows severe white corrosion after only 18 months in its ocean environment in Sarasota, FL. No coating remains.

Flaking and peeling occur on regular aluminum because air penetrates through the coating and corrodes the base metal. The devastation of the coating can occur rapidly when the job site is next to the ocean. Or it can take a much longer period of time in a more temperate climate. Either way, however, the castings will eventually show signs of corrosion. The scroll casting pictured at the top of this page has been on the ocean only 18 months and shows

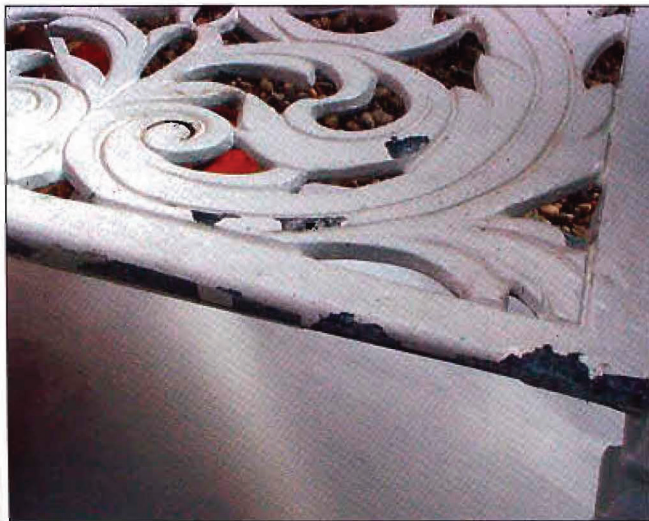
This 12-year-old aluminum furniture in Dallas, TX, is also not marine grade. Even though it is not in a harsh marine environment, its powder coat is peeling and corrosion appears.

almost complete disintegration; whereas the aluminum furniture (pictured below it, bottom of page 29) is located in the more moderate environment of Dallas, TX. In this less harsh environment the aluminum held off significant corrosion for 10 years. The furniture has now been in the weather 12 years.

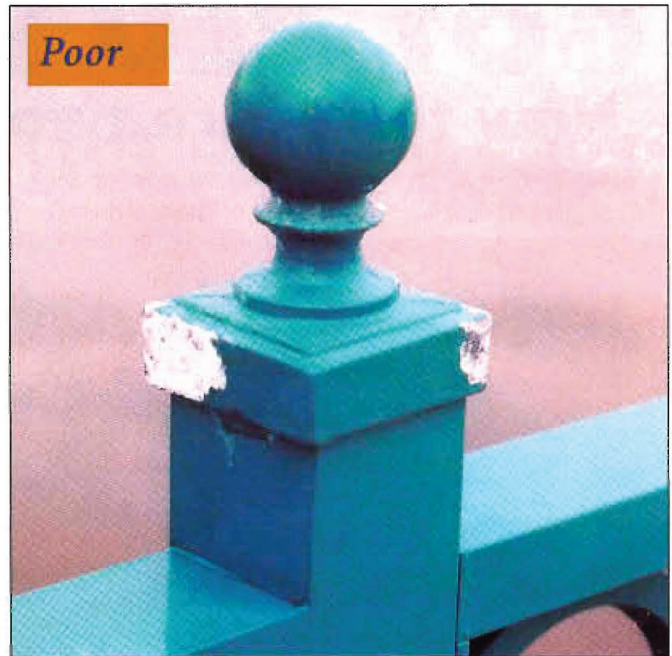
This 2" ball cap is not marine grade. It shows chalk corrosion and flaking (starting at corners) after four years on the Indian River in Vero Beach, FL.

Typical corrosion of non-marine aluminum castings is shown at left. The ball cap has been near the ocean for four years and shows the corrosion on the corner edges where only a thin layer of coating might have been applied. This edge with a thin coating enables the salt air to penetrate here first and begin the corrosion peeling action. The root cause of the white chalk aluminum corrosion is the residual amounts of copper that create a galvanic reaction with the aluminum base material.
